A STUDY OF THE EFFECTS OF FIRE ON ARCHAEOLOGICAL RESOURCES, PHASE I: THE HENRY FIRE, HOLIDAY MESA, JEMEZ MOUNTAINS, NEW MEXICO

> STEPHEN C. LENT JOAN K. GAUNT ADISA J. WILLMER

OFFICE OF ARCHAEOLOGICAL STUDIES

May 1993

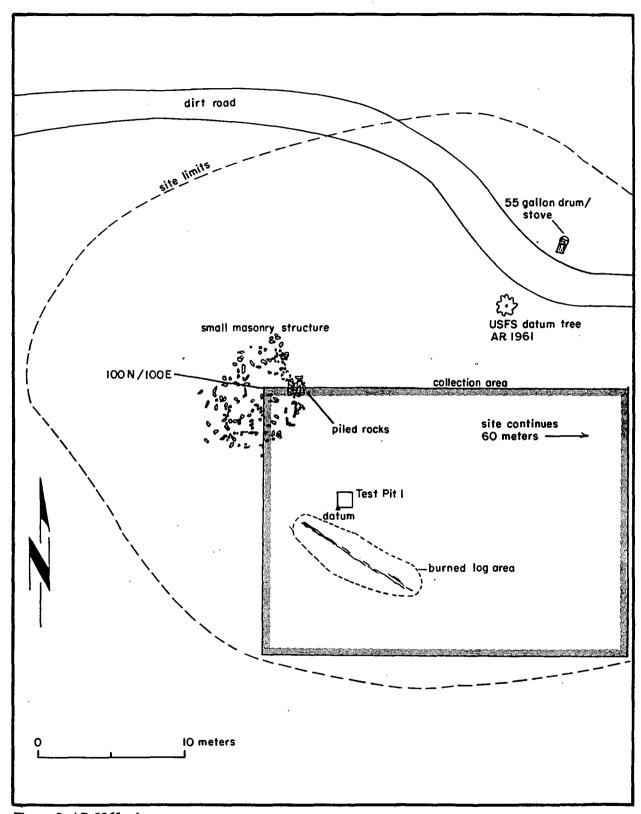
Figure 5. AR-1961, site map.

This site is classified as a lightly burned site. The ponderosa pine trees around the structure have been burned 4 ft above the ground surface, leaving behind green needles on the branches. Duff covers 70 percent of the surface of the site and is the result of new and old pine needle accumulation. One year after the fire, the surface of the site appears not to have been burned. The excavation unit, however, shows that the humus layer had been partly burned during the Henry Fire and a new layer of needles has since been deposited over the site. A burned log is present in the southeast quadrant. This highly burned element resembles the charred logs that were observed on heavily burned sites. It is hard to see surface artifacts except in the area of the burned log. The ground surface around the log has been charred leaving behind an ashy soil with no duff present. The artifacts in the vicinity of the log have been altered by the fire to a greater extent than the rest of the assemblage. The tuff blocks of the masonry structure, for the most part, have not been affected by the fire. Only on the eastern edge of the structure, where the piece of historic metal was located, did the fire generated enough heat to spall and crack the adjacent rock elements.

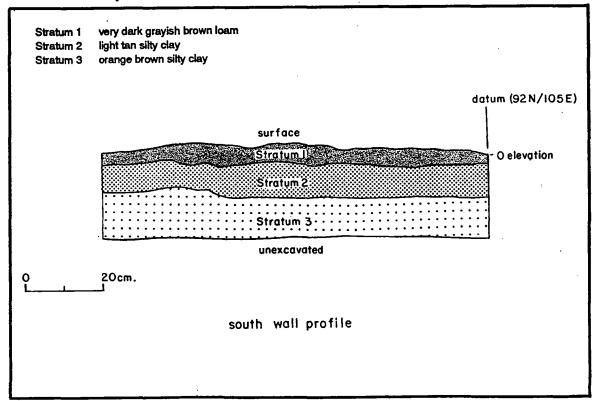
Figure 7. AR-1961, profile of Test Pit 1, south wall.

Test Pit 1 (92N/105E) was located 1.5 m north of the burned log area, the area of densest artifact concentration within the southeast quadrant. This excavation unit was dug to see if the Henry Fire affected any subsurface depositions. Arbitrary 10-cm levels were dug and three stratigraphic levels were defined. The surface was covered by a light layer of recently deposited needles. The only evidence of burning was the first centimeter of Stratum 1. The presence of charcoal in Stratums 2 and 3 may mean that Test Pit 1 was placed within the midden of the site. Figure 7 is a profile of the south wall of Test Pit 1, and a summary of the stratigraphy follows.

This stratum consisted of a humus layer 4 cm thick. The first centimeter was burned needles while the remaining 3 cm was a very dark grayish brown organic loam (humus layer). Artifacts were recovered in this layer.

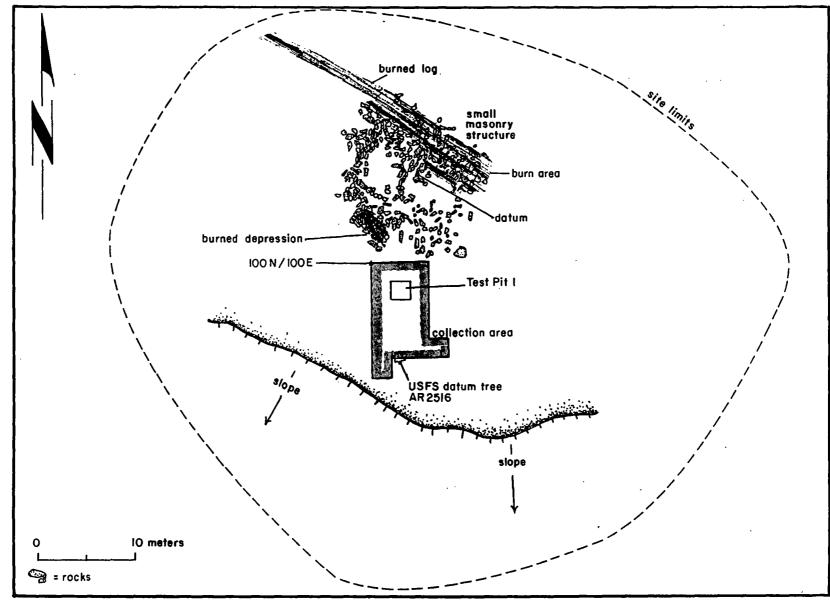
Figure 8. AR-2516, site map.

A large tree had fallen on top of the northern portion of the mound and completely burned; its residency time generated extensive damage to the underlying masonry elements. According to the research design, excavation was to be conducted if a log burned across the rubble mound. The log had burned over an area of wall fall and a decision was made to leave the structural elements in place. A detailed analysis of the burned area was documented. The northeast edge of the mound, a 7-by-1-m area, was exposed to intense heat. The majority of the stones within the shadow of the burned tree were blackened and reddened, while a few had been heated into a white friable stage. Five stones had burst apart and others were reduced to pea-sized crumbly tuff. One tuff stone had been completely oxidized and was significantly redder than the adjacent stones. Parts of other stones had deteriorated to powder.

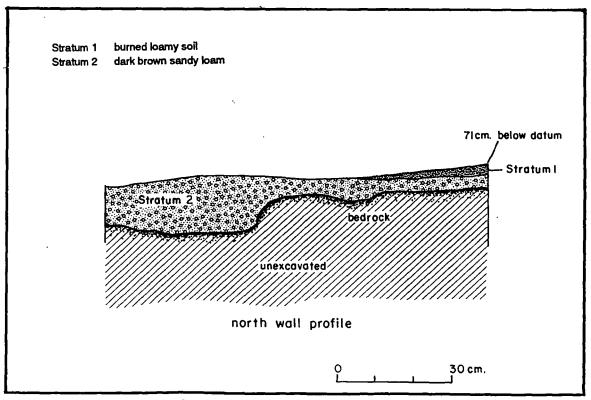
Figure 10. AR-2516, profile of Test Pit 1, north wall.

This layer varied between 4 and 15 cm thick and consisted of a dark brown sandy loam. The stratum was dominated by deteriorated welded tuff. The number of artifacts decreased sharply in this stratum. Excavation ceased when bedrock was exposed. There was some subsurface burning of roots.

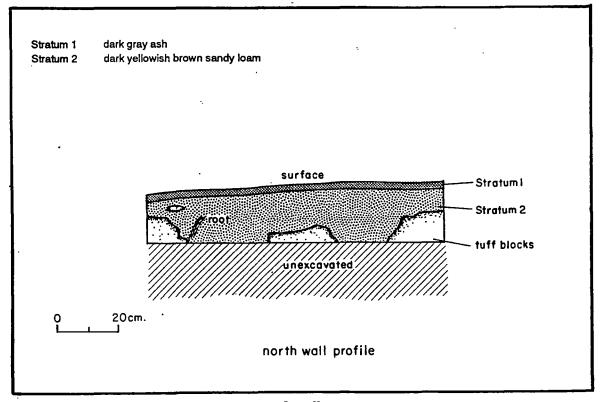
Figure 12. AR-1905, profile of Test Pit 1, north wall.

Test Pit 1 (94N/105E) was located within the heaviest artifact concentration of the southeast quadrant. Datum for Test Pit 1 was the grid's northeast corner and measures 109 cm below the site datum. Two levels were excavated defining two stratigraphic layers. The only evidence of the Henry Fire was a 2 cm ashy layer of topsoil. Figure 12 is the north wall profile of Test Pit 1; a summary of the stratigraphy follows.

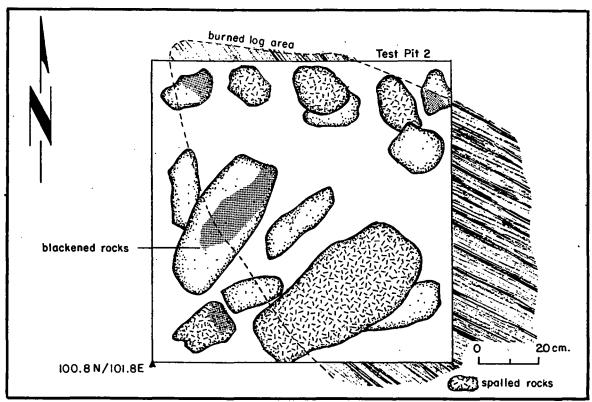
Figure 13. AR-1905, plan of Test Pit 2, base of layer 2.

Test Pit 2 (100.8N/101.8E) was placed on the collapsed architecture where a log had completely burned leaving only a charred area. The datum for the test pit was in the southwest corner, 30 cm below the site datum. Two levels were excavated to determine the effect of burning caused by the longer residency time of the burned log. Effects of the Henry Fire were evident by the surficial cobbles being blackened, reddened, and more spalled than other areas at the site. Excavation revealed that this area of the structure consisted of wall fall from the northeast corner and possibly interior portions of the structure. The stratigraphy in this test pit was similar to Test Pit 1. Figure 13 is a plan view map showing the subsurface burned areas of the wall fall in Stratum 2; a summary of the stratigraphy follows.

This stratum consisted of a gray ashy topsoil 1-3 cm thick. It contained cobbles, ash and charcoal, deteriorated bedrock, and a few rootlets. A few artifacts were present in this stratum.

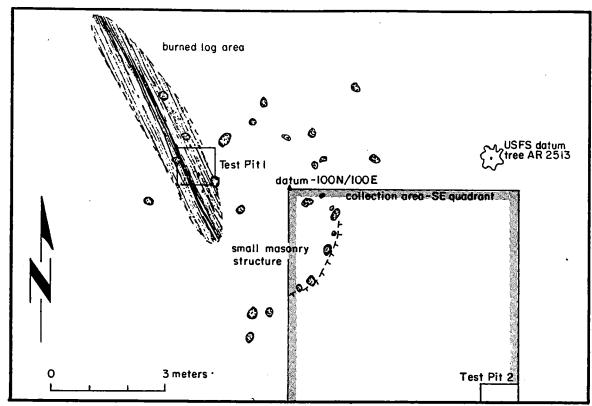
Figure 15. AR-2513, detail of structure and burned log area.

This site was classified as moderately burned. The trees have been burned from 9 to 12 ft, leaving some needles on the branches. The duff was burned between the trees, exposing a very burned ground surface. At the base of the trees there are still some partly charred needles present, probably because the duff was thicker in these areas. Of the tuff blocks, 100 percent were effected by the fire and these are spalled, exploded, disintegrated, and blackened.

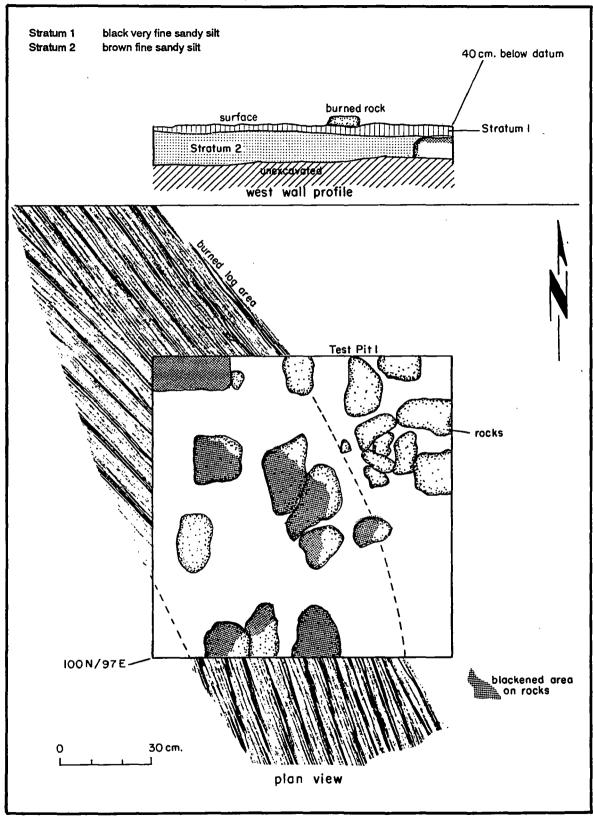
Figure 16. AR-2513, plan and profile of Test Pit 1.

Test Pit 1 (100N/97E) was situated in an intensely burned area where a tree had fallen across the structure and completely burned. This heavily burned area extended across the grid from the south-central portion to the northwest corner of the grid. The humus layer was burned away leaving behind

a blackened sandy soil. Branches of the log were imbedded in the ground, resulting in the soil being burned to varying depths (2-10 cm below the present ground surface). It is uncertain if the tree fell while burning or burned on the ground. The east half of this unit exposed wall fall and this was left intact. In the southwest quadrant, under the burned area, is a blackened rock 5 cm below ground surface (Fig. 16). Newly fallen needles lightly covered the ground surface. Two stratigraphic levels were (Fig. 16). Stratigraphy of the west wall profile follows.

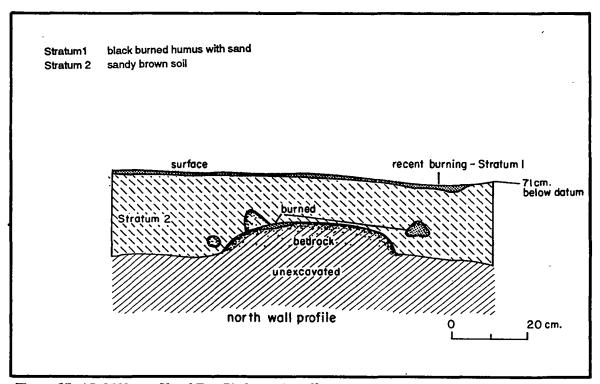
Figure 17. AR-2513, profile of Test Pit 2, north wall.

Test Pit 2 (94N/105E) was excavated in a dense artifact concentration (possible midden) within the southeast quadrant. The datum for Test Pit 2 was the northeast corner of the test pit and was 64 cm below the site datum. Effects of the Henry Fire were evident in the top 2 cm of burned and blackened humus. Two strata were defined in this test pit and are illustrated below (Fig. 17). Descriptions of the stratigraphy follow.

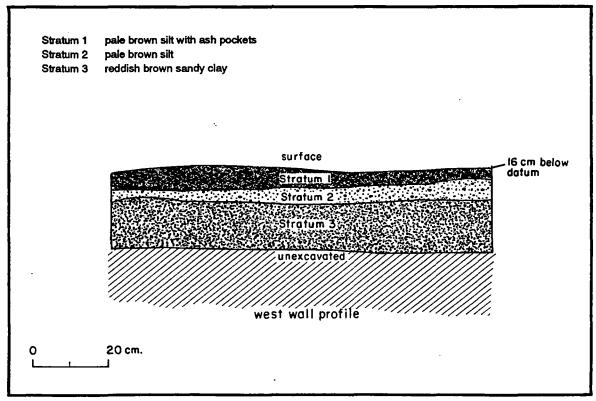
Figure 20. AR-1930, profile of Test Pit 1, west wall.

Test Pit 1 (98N/106E) was placed in the southeast quadrangle to determine the extent of burning below the ground surface. The surface of the excavation unit consisted of a brown sand with areas of gray ash. All the pine needles had been burned away by the Henry Fire. This test pit was excavated in arbitrary 10-cm levels and a total of three stratigraphic layers was defined. Test Pit 1 was located within a midden and artifacts were found at the base of Stratum 3. The effects of the Henry Fire had only altered the first 5 cm of soil; other evidence of burning in Test Pit 1 was cultural and due to the presence of the midden. Figure 20 illustrates the stratigraphic profile of the west wall of Test Pit 1.

Stratum 3 is an organic middenlike layer with burned clay, charcoal flecks, and ash. The burning exhibited here is probably due to the area being utilized as a trash dump where embers and other burned material was discarded. This layer was composed of an olive-colored, burned sandy clay with charcoal flecks, some ash, and a few tuff cobbles. The artifact density increased in this stratum.

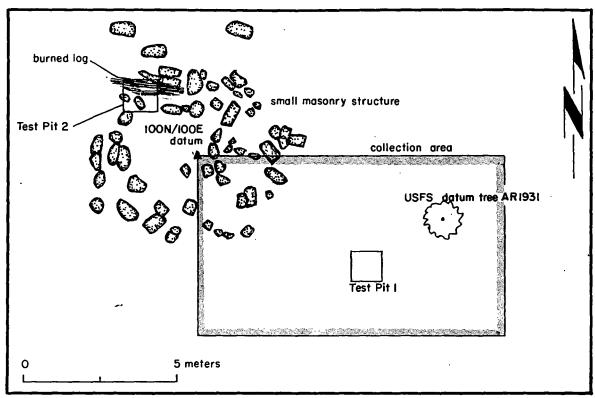
Figure 22. AR-1931, detail of structure and burned log.

Work at the site included dividing the site into quadrants and establishing a grid system. A site datum (permanent rebar) was placed within the masonry structure at 100N/100E; an arbitrary designation was made for 0.0 elevation of the site that was 10 cm above the ground surface at the site datum. A sample of surface artifacts (lithic material and ceramic items) was collected from the southeast quadrant and included grids 94N to 99N and 100E to 109E (54 sq m). Isolated lithic artifacts outside of the collection area were collected by their grid designation. Ground stone fragments outside of the sample were also collected. Of the two test pits excavated, Test Pit 1 (96N/105E) was placed within the southeast quadrant, and Test Pit 2 (101.5N/97.5E) was located in the structure near the burned log (Fig. 22).

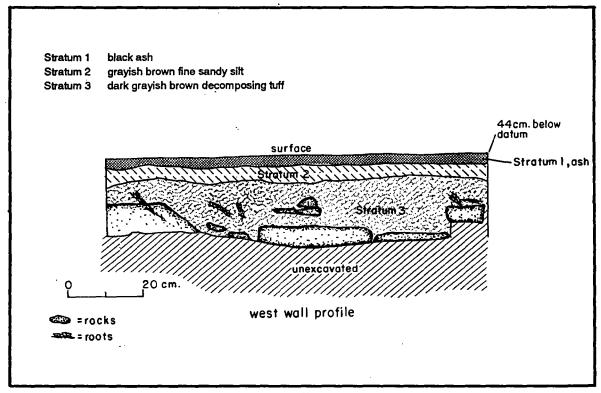
Figure 23. AR-1931, profile of Test Pit 1, west wall.

Test Pit 1 (96N/105E) was excavated to determine the extent of burning below the ground surface. Datum for this test pit was the main site datum. The surface of the excavation unit was completely void of pine needles and was covered by a gray to black ash. A few clumps of grass were beginning to grow back. Test Pit 1 was dug in arbitrary 10-cm levels. Two 10-cm levels were attempted, but decomposing bedrock and tree roots were encountered 6-8 cm below the ground surface. The only

evidence of burning in this test pit was the first 2 cm of soil (Stratum 1). Figure 23 is the west profile of Test Pit 1 and following is the strata description.

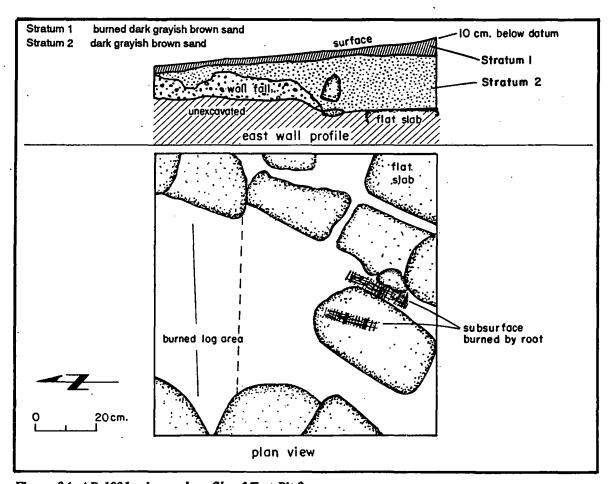
Figure 24. AR-1931, plan and profile of Test Pit 2.

Test Pit 2 (101.5N/97.5E) was placed within the area of the burned log, in the vicinity of the northwest corner of the structure. The datum for this test pit was the main site datum. This excavation unit was excavated to see if the extended residency time of the burning log had an effect on the architectural elements or any other features or artifacts within the structure. Two arbitrary 10-cm levels were dug. When wall fall was encountered it was not disturbed in order to preserve the structural integrity of the masonry feature. Immediately beneath the burned log, the tuff elements were highly blackened and evidence of subsurface burning was apparent in Stratum 1. Descriptions of the stratigraphy are listed below and are shown in the east profile of Test Pit 2 (Fig. 24).

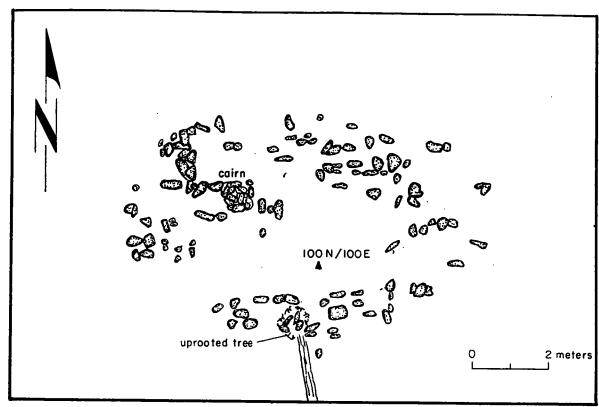
Figure 26. AR-1886, detail of structure.

The site was divided into quadrants and a grid system was established from 100N/100E located within the masonry structure. A sample of surface artifacts was collected from the southeast quadrant and includes grids 94N to 99N and 110E to 117E (48 sq m). The duff in these grids had to be removed in order to obtain better visibility of the surface artifacts; a higher number of artifacts was collected than was originally thought to be present. One isolated, blackened hammerstone was collected outside of the collection unit within grid 102N/108E; this is the only fire-altered artifact present at the site and it may have been affected by fire because of previous forest fires or was a cultural alteration to the artifact. Test Pit 1 was placed within the surface collection area, in the area of highest artifact density. The datum for this site is located at the southwest corner of the test pit and 0.0 m elevation for this site was 10 cm above the ground surface. A piece of rebar was left to permanently mark the site datum. Ten percent of the tuff building blocks exhibit natural erosion, such as deterioration and very light spalling. Lichen was growing on 90 percent of the tuff elements (Fig. 26).

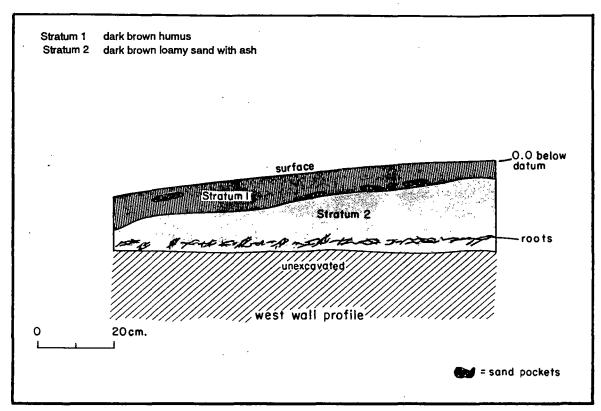
Figure 27. AR-1886, profile of Test Pit 1, west wall.

Test Pit 1 (95N/112E) was located downslope and to the southeast of the masonry structure. It was placed within the southeast quadrant in the surface collected area. Two arbitrary 10-cm levels were dug and two stratigraphic layers were defined. No subsurface burning was noted in this excavation unit. Figure 27 shows the west profile of the test pit and following is the stratigraphic description.

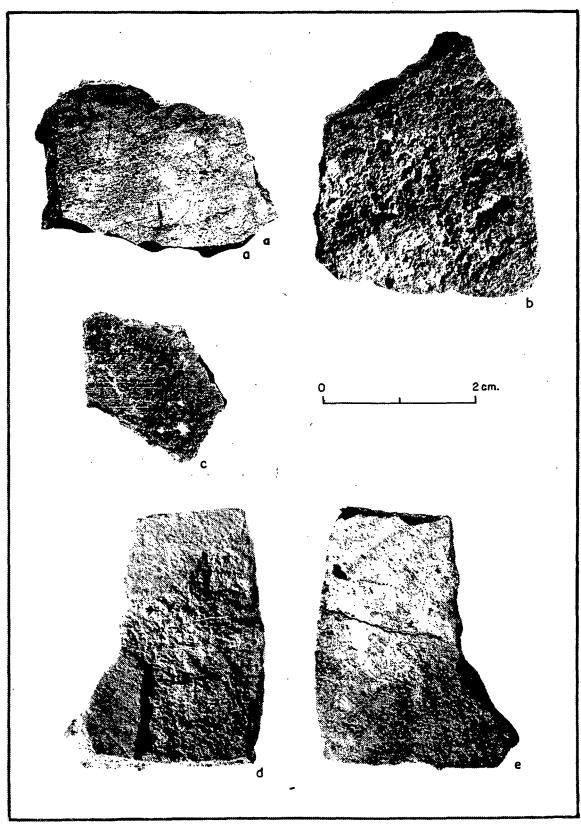
Figure 28. Examples of pottery affected by fire; (a) AR-1961, sooting and crazing on white ware sherd from the burned log area; (b) AR-2513, Jemez Utility ware exhibiting medium sooting; (c) AR 2513, adhesions on a white ware sherd; (d) AR-1930, heavily fire-damaged white ware sherd exhibiting spalling and cracking, interior and exterior views.

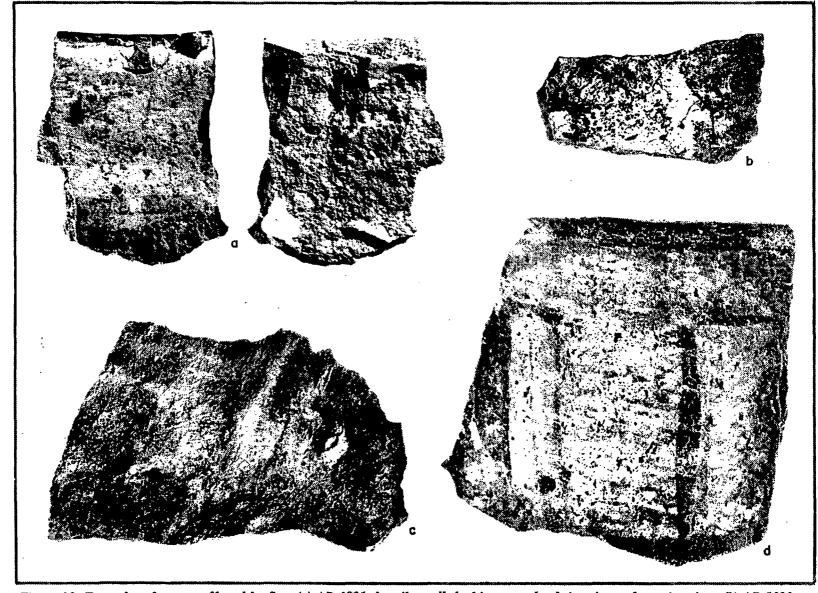
Figure 29. Examples of pottery affected by fire; (a) AR-1931, heavily spalled white ware sherd, interior and exterior view; (b) AR-1930, heavy adhesions on white ware sherd; (c) AR-1931, adhesions on a white ware sherd from a heavily burned site; (d) AR-1930, heavily burned polychrome sherd.

At AR-2513, a large burning log affected artifacts, and even subsurface structural materials to a depth in excess of 20 cm. The subsurface burning at AR-1931 was largely the result of the combined effect of a burning log resting on the structure, and burning roots that had been ignited by the log.

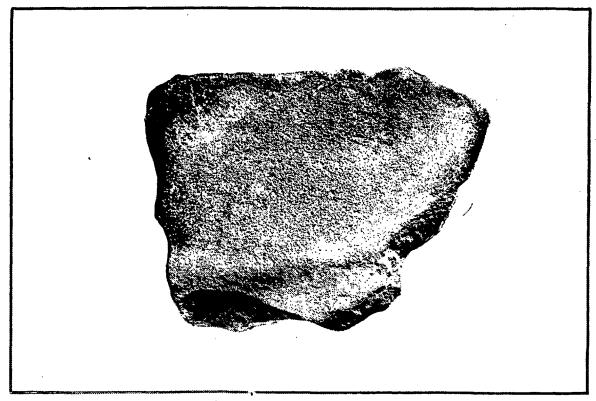
Discussion. Fire damage from the Henry Fire has affected ground stone from lightly and heavily burned sites. At the lightly burned site (AR-1961) the ground stone items were either not affected or were partly reduced to a blackened state. The highly burned sites, on the other hand, showed medium to high burning characteristics. They were affected by the fire over a higher percentage of their surfaces than was found with the lightly burned artifacts. Fire effects on ground stone artifacts for highly burned sites included sooting, oxidation, reduction, and some adhesions.

Figure 30. AR-1930, sooted ground stone.

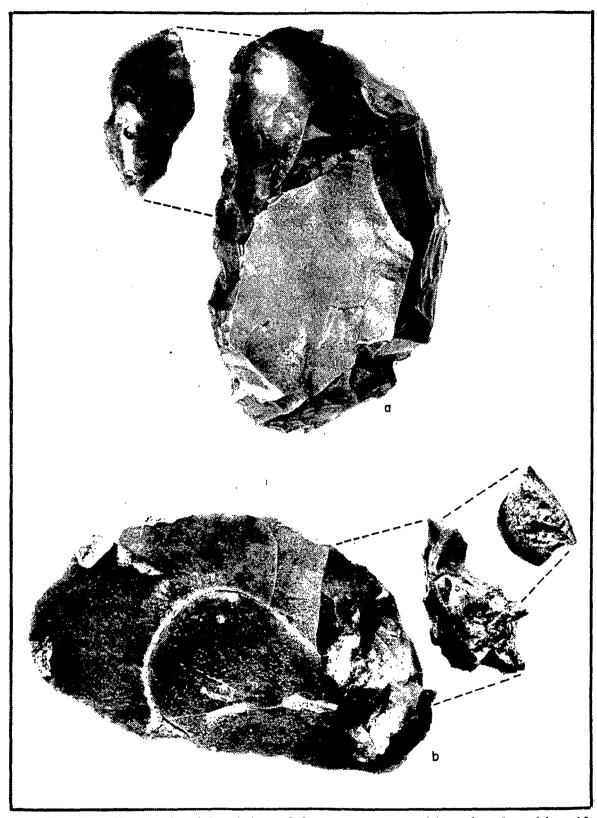
Figure 31. AR-2513, ventral and dorsal views of chert scraper recovered beneath a charred log with potlids.

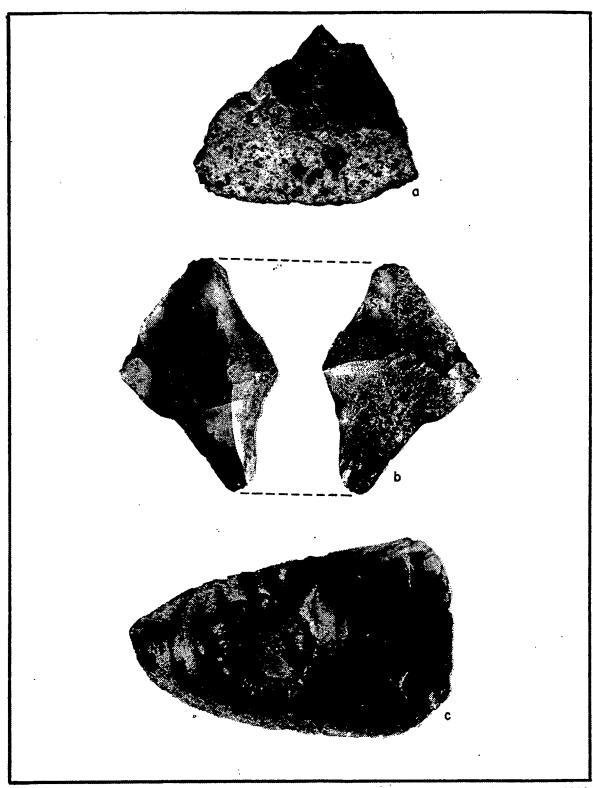
Figure 32. Various lithic artifacts affected by fire; (a) AR-2513, sooted rhyolite artifact; (b) AR-1930, subsurface lithic artifact exhibiting adhesions and crazing; (c) AR-1931, potlid removed from the ventral side of an obsidian artifact.
